Subject: 10CFR21 Reporting of Defects and Non-Compliance -
Engine Systems, Inc. Report No. 10CFR21-0089, Rev. 0

Woodward Governor "Compensating" EG Series Actuators

Report No. 10CFR21-0089

10CFR21 REPORTING OF DEFECTS AND NON-COMPLIANCE

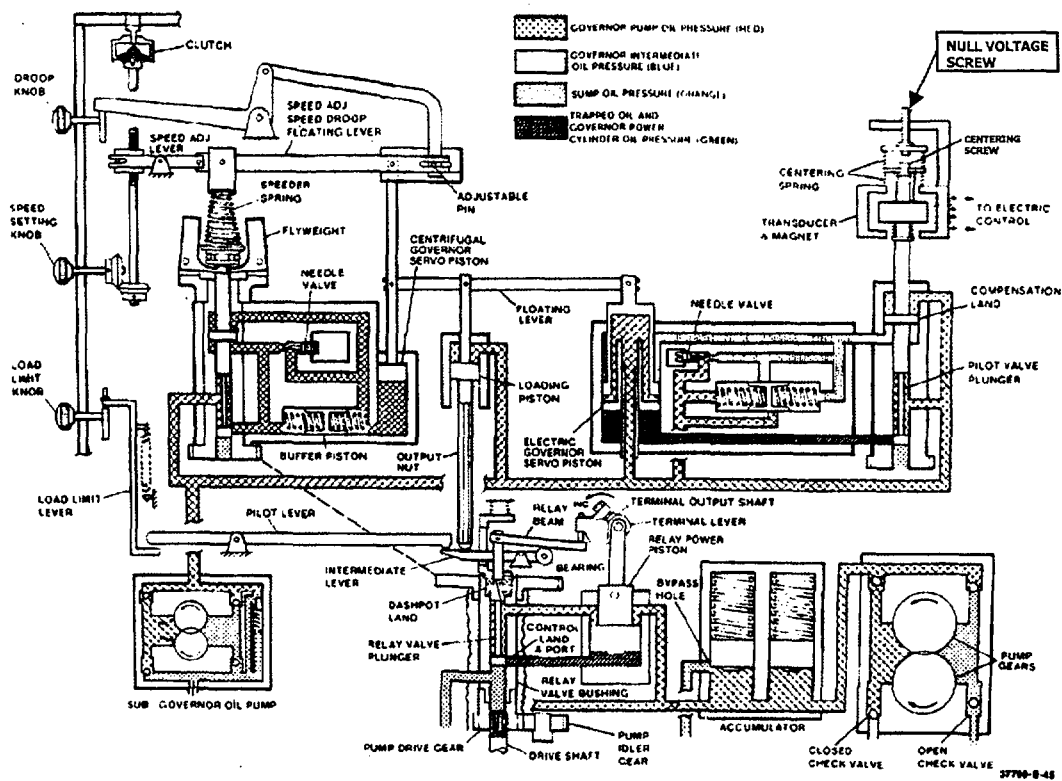
FIGURE 1: TYPICAL EGB-C "COMPENSATING" GOVERNOR

Proportional actuators (EGB-13P, 35P, etc.) have an internal feedback (a mechanical link) between the electrical power piston and electrical section pilot valve. This feedback, which is not provided on the compensating actuators, eliminates the concern of drift because any deviations within the centering restoring spring, pilot valve, etc. are overcome as the power piston and pilot valve come to equilibrium. Reference Figures 1 and 2.
